Chesapeake Boulevard (between East Little Creek Rd & Fishermans Rd) Pedestrian & Drainage Preliminary Engineering Report

City of Norfolk, Virginia

Department of Public Works

Timmons Group

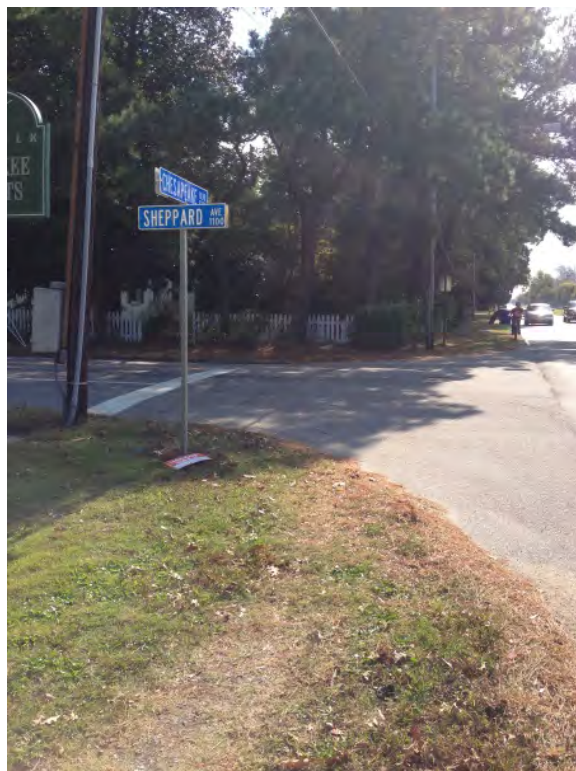
An observation of the current walking conditions along Chesapeake Boulevard between East Little Creek Road and Fishermans Road has been made. Timmons Group has found that little to no constructed sidewalks are available on either the western or eastern sides of the corridor. Walking from East Little Creek Road to Fishermans Road requires traversing grass, asphalt, gravel, dirt/mud and a small stretch of concrete walks. Footpaths which have been created by high pedestrian traffic exist along the edge of asphalt on both sides of Chesapeake Boulevard. In most cases these footpaths were within a relatively clear 8-10' grass/gravel strip just off the

Figure 3. Example of pedestrian access along the Chesapeake Boulevard corridor.

edge of asphalt. Several above ground utility structures, light poles, guy wires, trees, etc. exist within the center grassed median as well as along both sides of the corridor.

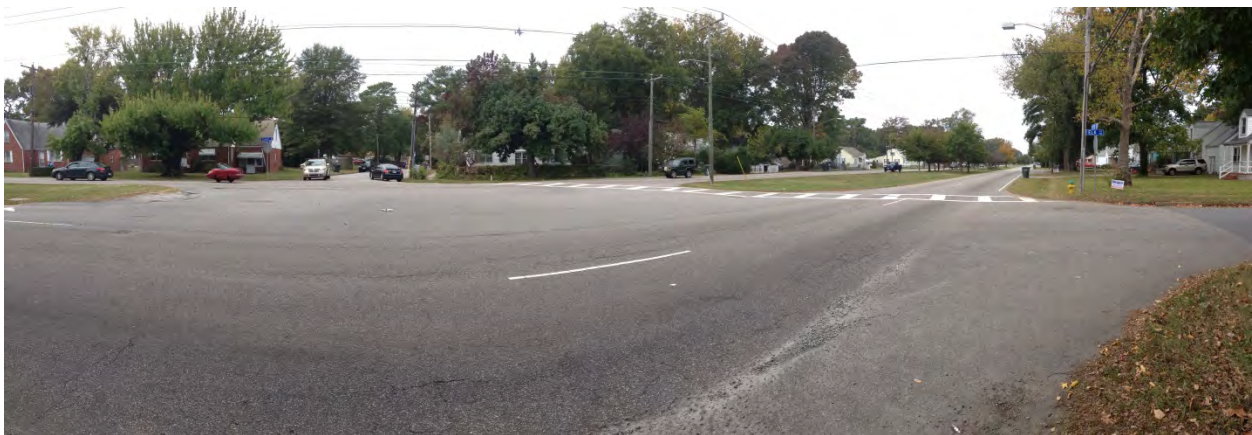
Only one pedestrian crosswalk, located at Brentwood Drive or Elk Avenue, is available within the project extent which allows pedestrians to cross Chesapeake Boulevard. This crosswalk lacks a completely accessible path due to the lack of interconnectivity of the adjacent sidewalks and clearly serves pedestrians currently as determined by the footpaths observed during the site visit. Improvements to this intersection such as the implementation of a traffic signal, ADA ramps, additional sidewalk and pedestrian refuges should be assessed.

Figure 4. Panorama of Elk Ave/Brentwood Drive Intersection: Southeast Corner Looking North and West.

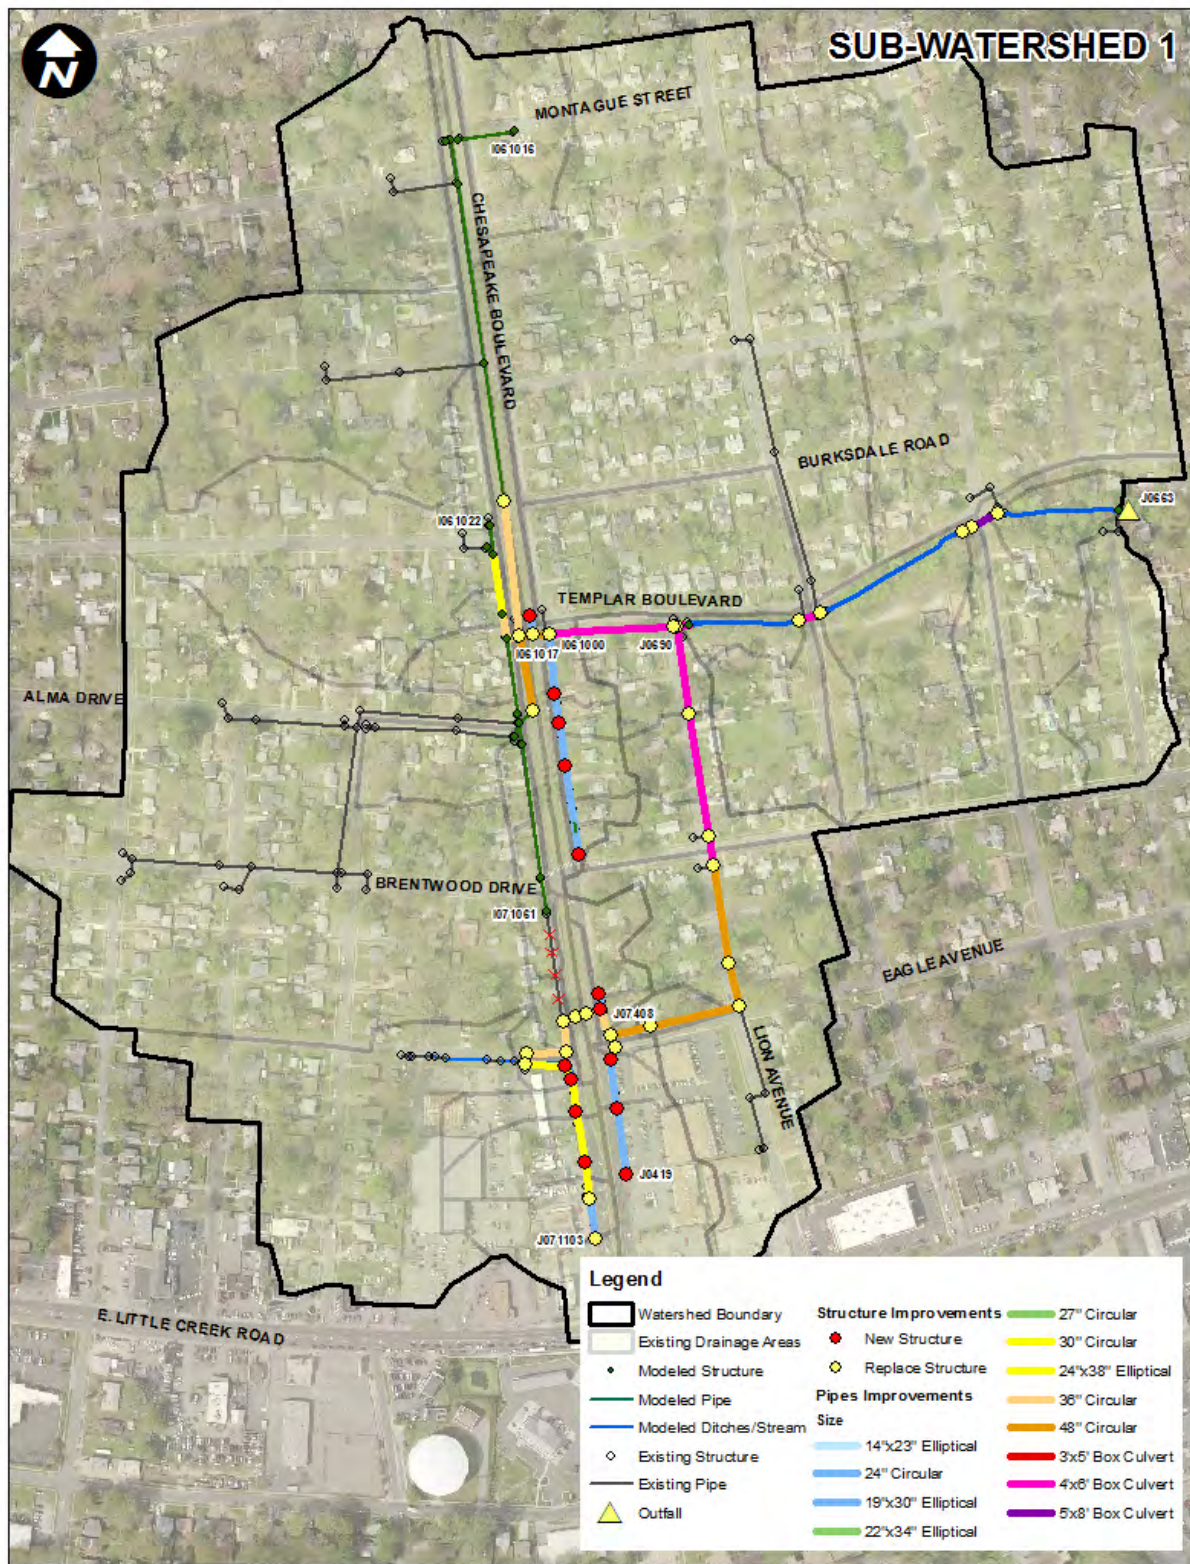
Figure 7. Sub-Watershed 1 Increased Pipe Capacity Alternative

Figure 7 illustrates the improvements recommended above. This alternative eliminates along the main trunk line but does not eliminate flooding along Montague Avenue. Hydraulic grade line profiles for the main trunk system and each critical location are illustrated in Appendix D. The total estimated cost of this alternative is \$4,718,473.00. A detailed cost estimate is found in Appendix F.

This alternative assumes that culvert improvements have been made downstream. In order to reduce flooding within sub-watershed 1, Timmons recommends removing the upstream ditches along Chesapeake Boulevard towards the intersection with East Little Creek Road and replacing with 24" pipe. In addition, flow should be rerouted to the existing branch system along Lion Avenue. To effectively reroute flow, the pipes along Lion Avenue should be increased in capacity to the equivalent of 4'x6' box culverts and 48" pipe respectively.

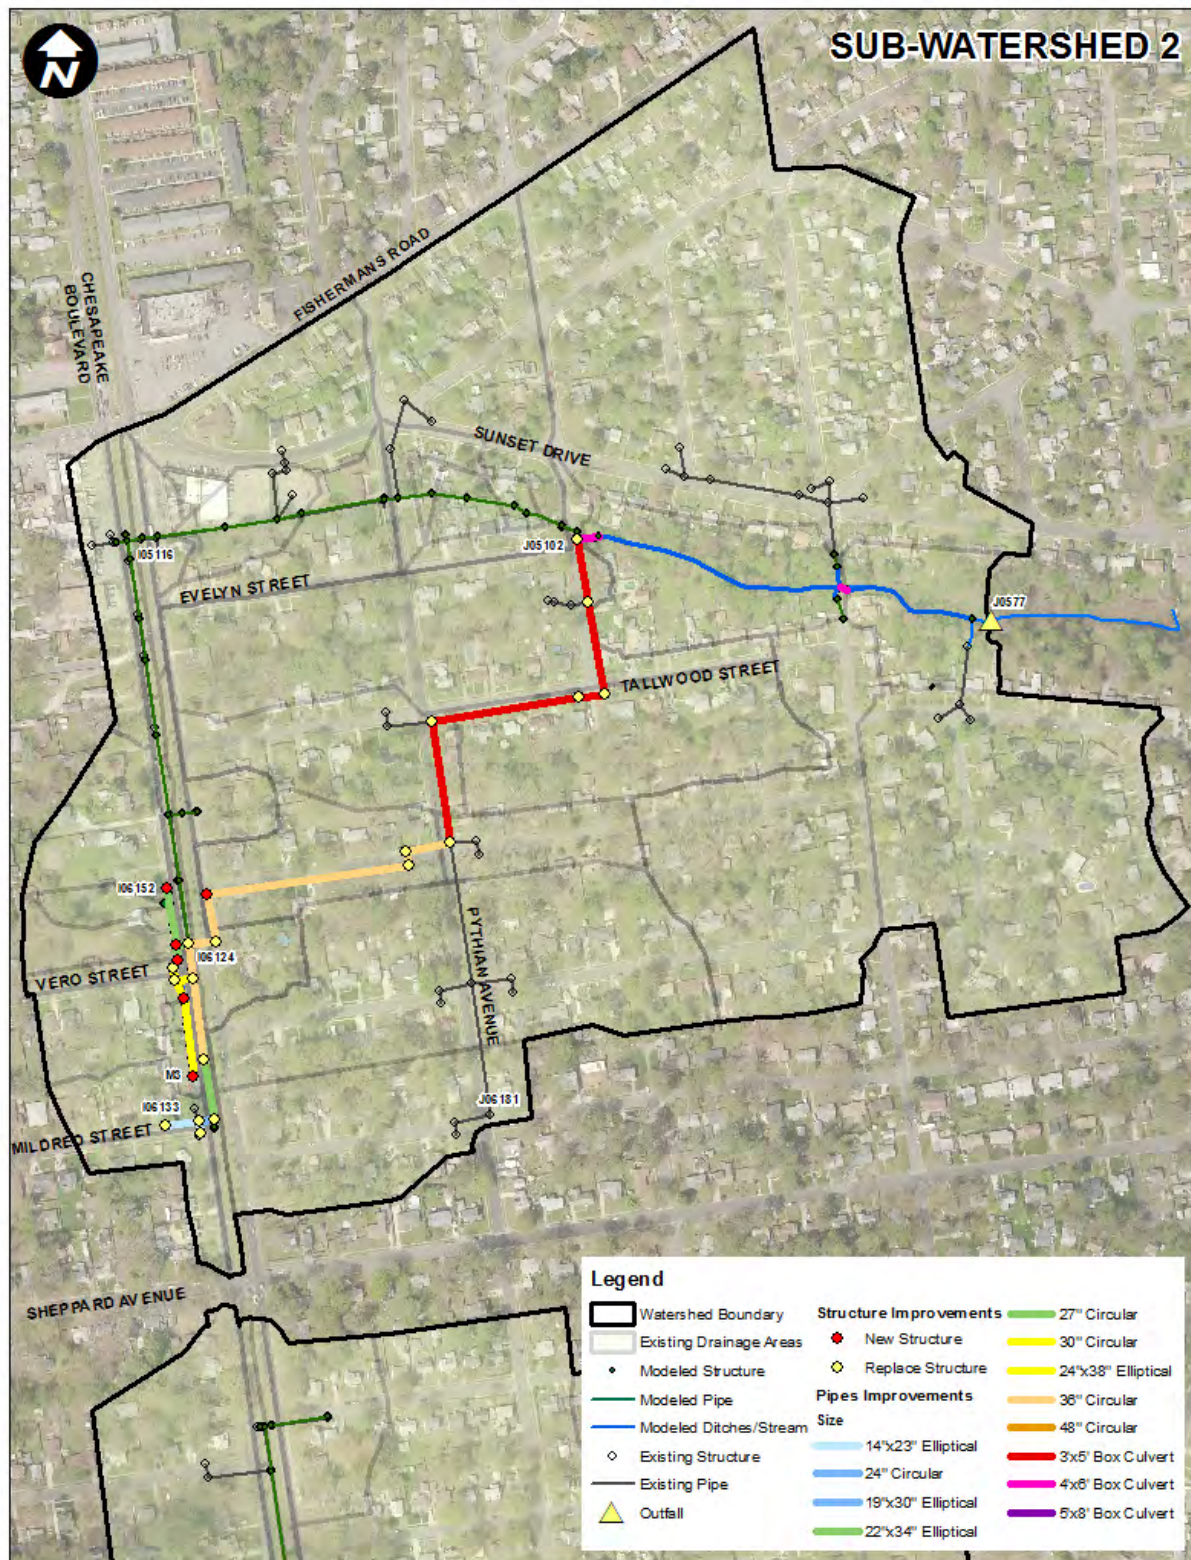
Figure 8. Sub-Watershed 2 Increased Capacity Alternative

Currently, significant flooding occurs along Chesapeake Boulevard between Mildred and Vero Streets, and behind the residences between Evelyn Street and Sunset Boulevard. To eliminate flooding between Mildred and Vero Streets and reduce flooding behind residences, Timmons recommends rerouting flow from upstream along the existing branch system along Pythian Avenue and Tallwood Street. This alternative assumes that culvert improvements have been made downstream.

Increasing the capacity throughout both sub-watersheds by replacing stormwater infrastructure at lower inverts and with larger pipes is very costly. Box culverts were used in this analysis, however the potential cost benefit of using dual circular or dual elliptical pipes of equivalent capacity could be investigated. In addition, Timmons Group recommends looking into the use of pump stations.

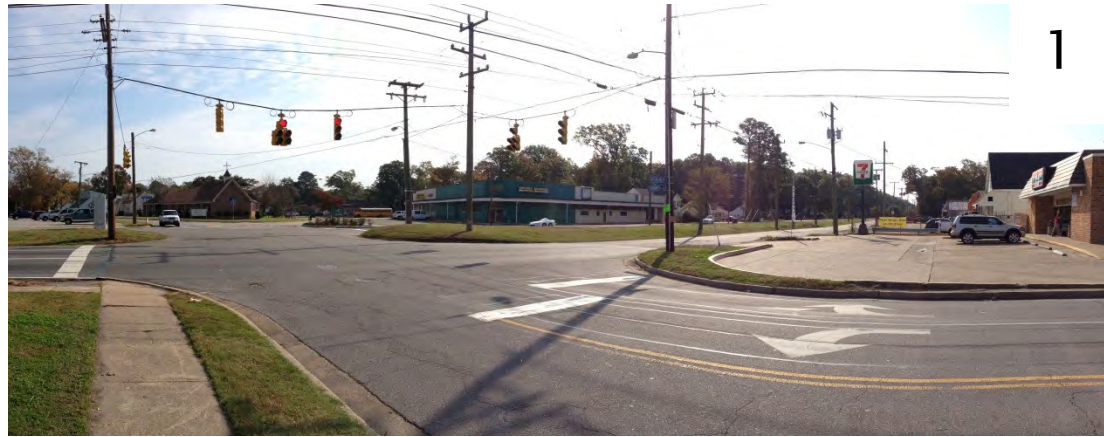
1

1. Facing east to intersection of Chesapeake Blvd and Fishermans Road (Panorama)
2. Facing west away at Bill Street Intersection
3. Facing south near Newell Street Intersection
4. Facing south away from Fishermans Road
5. Facing south at Tallwood Street Intersection
6. Facing south in center median
7. Facing north on west side of boulevard, just south of Vero Street Intersection

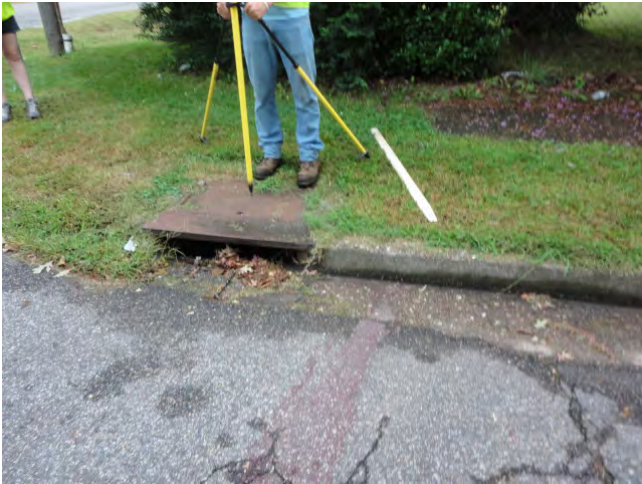
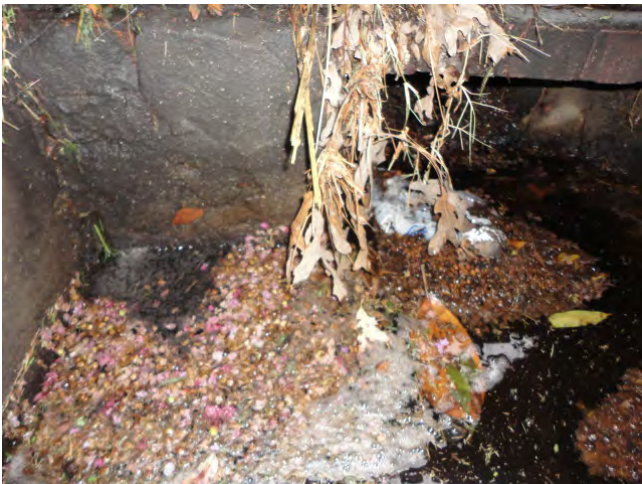
Structure Number **I06137**

Notes: 0.5' of water in structure

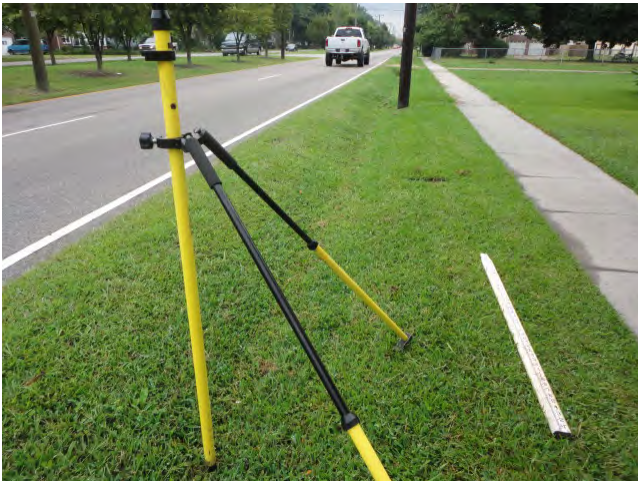
Notes: portion is v-ditch; good condition

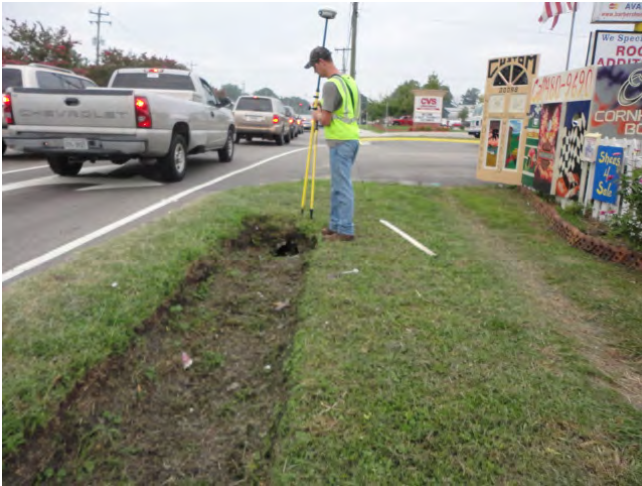
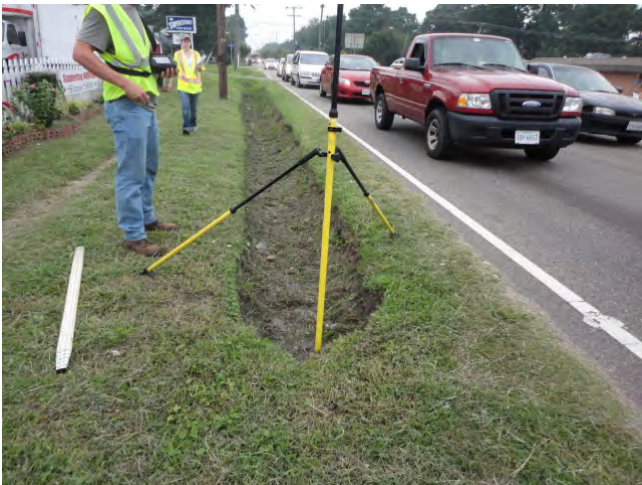
Structure Number **J071098**

Notes: lots of grass clippings
